## Inspection Report

Chicago IL

## Domicile Consulting

<b>Date:</b> 11/14/2009	<b>Time:</b> 01:00 PM	<b>Report ID:</b> 11/14/09/01
<b>Property:</b> Chicago IL	<b>Customer:</b>	<b>Real Estate Professional:</b>

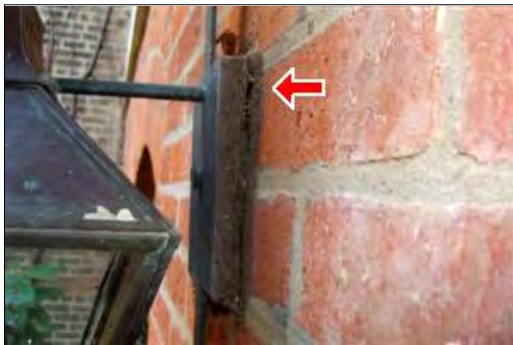
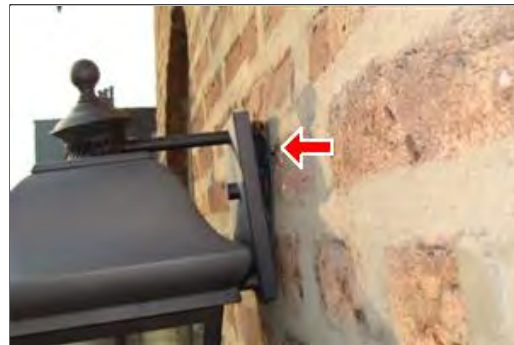
(2) (Picture 2)(Picture 3) Caulking is recommended at the top and sides of the exterior electrical lighting fixtures in order to prevent moisture penetration into the home and/or moisture contact with energized electrical equipment.

A. Picture 2

A. Picture 3 South Elevation Light Fixture

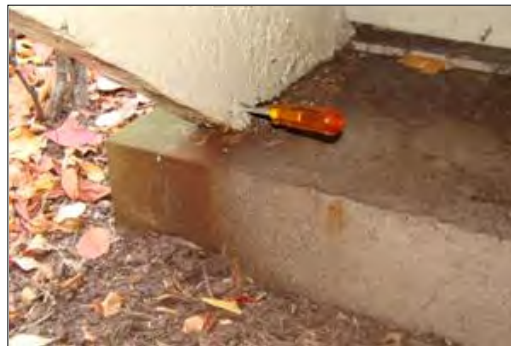
A. Picture 4

(3) (Picture 4) Wood rot was noted at the base of the front porch stair stringers. Repair by a qualified carpenter is recommended.

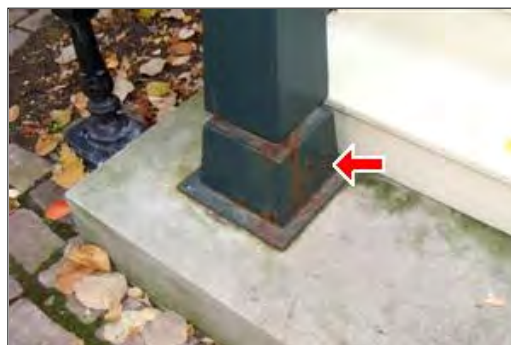
A. Picture 5

(4) (Picture 5) The metal railing posts at the front porch/stairs should be professionally painted to prevent ongoing corrosion and damage.

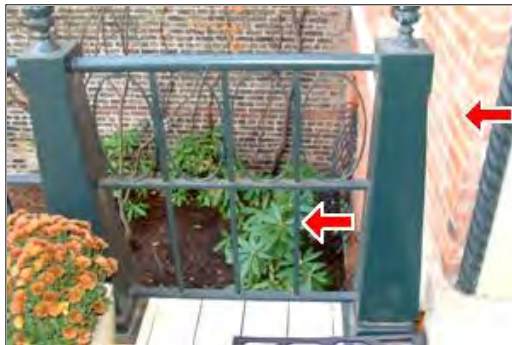
A. Picture 6

(5) (Picture 6) The porch railings do not conform to modern safety standards. It is recommended that they be altered so that no spaces wider than 4" exist at the railings; failure to conform to the modern standards increases the risk for injuries, especially to children.

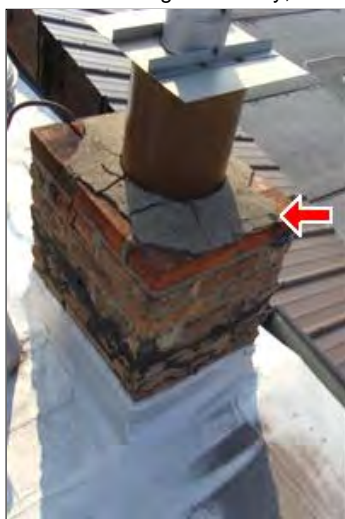
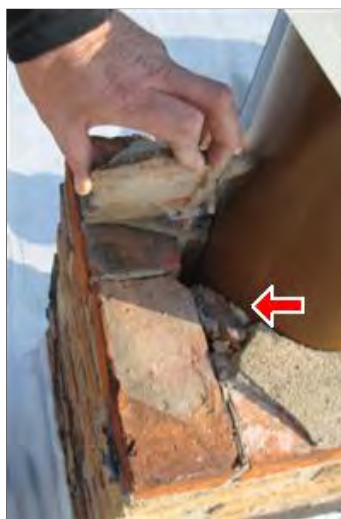
(6) (Picture 7)(Picture 8) The masonry chimney on the west side of the roof is deteriorated. It should be repaired or rebuilt by a qualified masonry contractor. The cost of repairing the chimney should be compared to the cost of replacing the gas-fired furnace it serves to vent against the cost of replacing the furnace with a high efficiency, sealed combustion unit which does not require chimney venting.

A. Picture 8 Chimney Deterioration

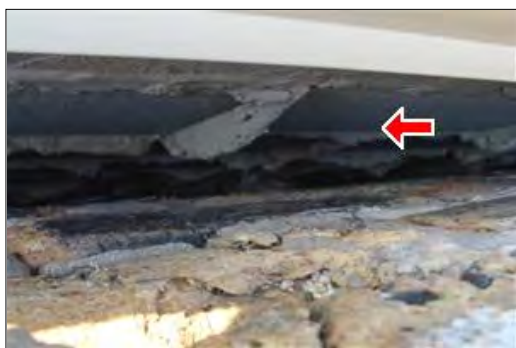
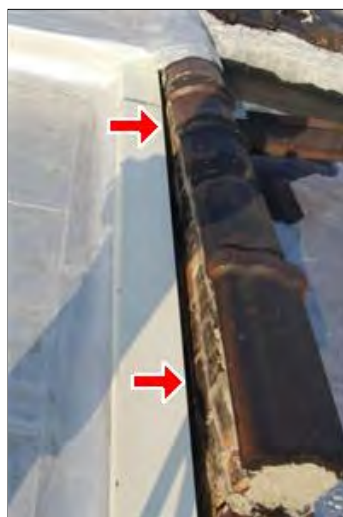
(7) (Picture 9)(Picture 10) The space between the subject building and the building to the east at the parapet wall should be sealed with aluminum flashing or equivalent to prevent moisture from being drawn into the unsealed and inadequately tooled mortar joints of the east exterior wall.

A. Picture 9 Concrete Block Wall at East Elevation

A. Picture 10 Gap Between Buildings

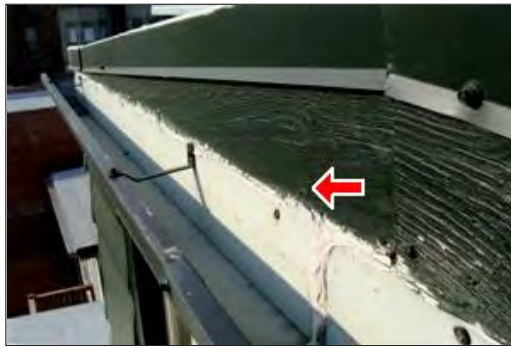
(8) (Picture 11) The top edge of the south gutter at the upper roof level is not sealed or protected with flashing. This could allow moisture to become trapped behind the gutter back resulting in wood rot and damage. The installation of flashing between the top of the gutter back and the bottom of the gravel stop is recommended.

A. Picture 11 Open Gutter Back

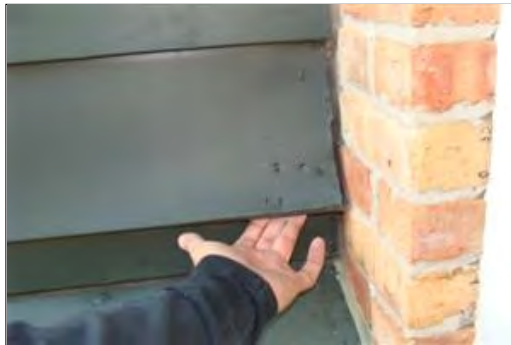
A. Picture 12

(9) (Picture 12) The aluminum siding at the rear top floor entry door is loose and should be secured or replaced by a qualified contractor.

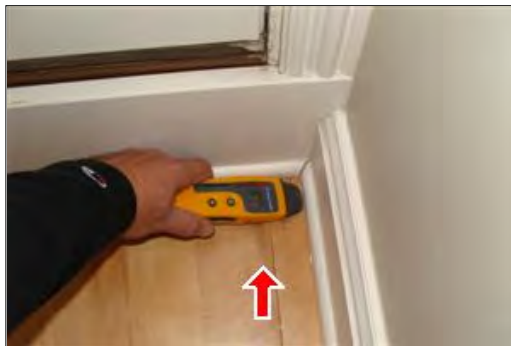
(10) (Picture 13) Elevated moisture readings were found at the lower right hand corner of the top floor rear entry door. It may be necessary to remove some siding, trim, or flashing at the outside wall in this location in order to track down the source of the moisture intrusion. This type of moisture intrusion detection is not a part of this home inspection. Further review by a qualified moisture intrusion or remediation contractor is recommended.

A. Picture 13 Elevated Moisture at Wood Floor

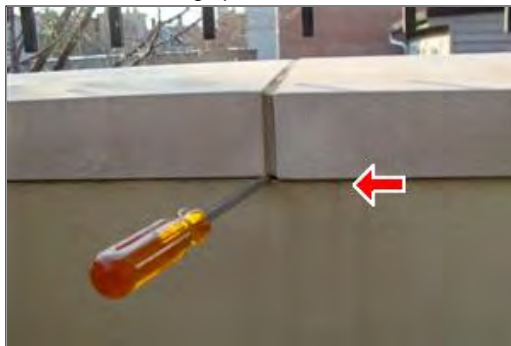
(11) (Picture 14) The gap at the top edge of the stucco wall cladding at the perimeter of the rear balcony should be sealed against moisture intrusion and entrapment by a qualified stucco coating specialist.

A. Picture 14 Gap at Top of Stucco Finish

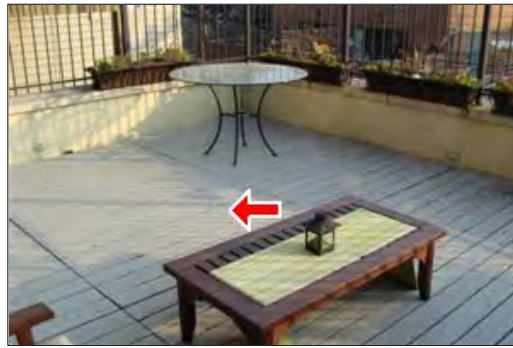
A. Picture 15

(12) (Picture 15) All exterior wooden deck surfaces should be professionally cleaned and sealed against weather in order to extend the service life of the materials.

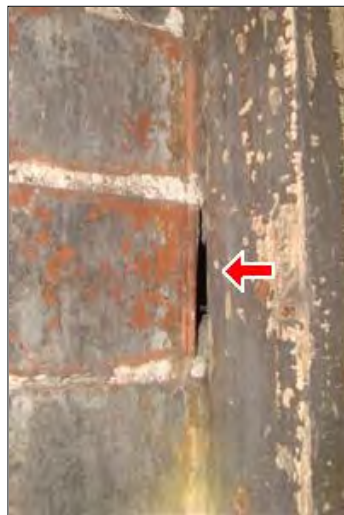
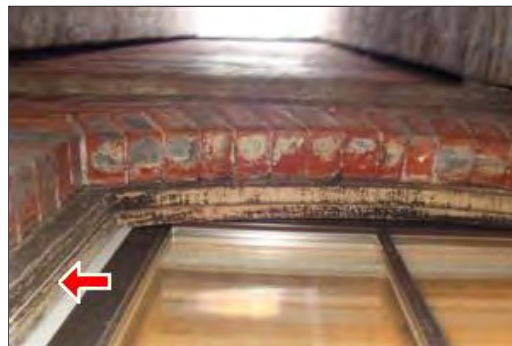
(14) (Picture 17)(Picture 18) The window in the light well is not adequately protected with paint nor is it properly sealed with caulk. The window also presents an avenue for relatively easy access into the home. The window should be painted, caulked, and secured against unauthorized entry.

A. Picture 17 Missing Caulk

A. Picture 18 Light Well Window

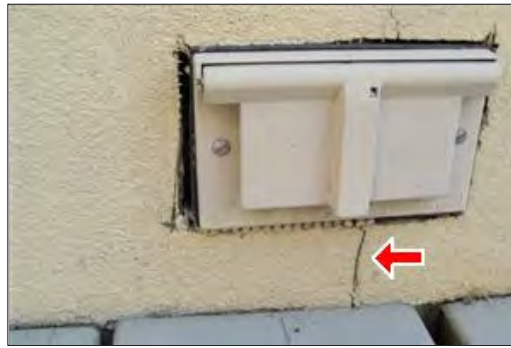
(15) (Picture 21) The stucco wall finish at the second floor balcony is cracked and should be repaired.

A. Picture 19 Stucco Cracking

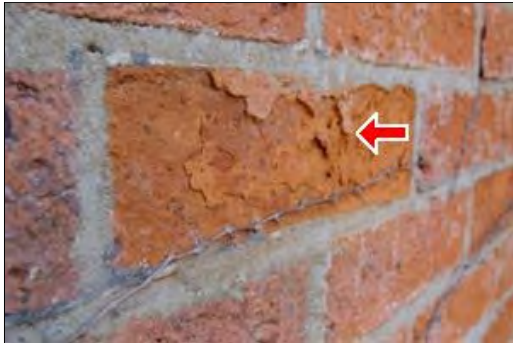
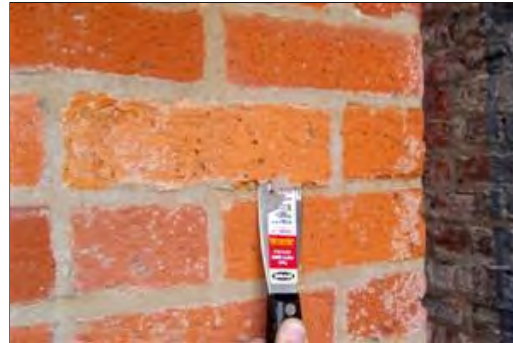
(16) (Picture 22)(Picture 23) The face brick on the north elevation of the home appears to have been damaged by sand-blasting or other abrasive cleaning. The brick are exhibiting spalling, flaking, and appear to be overly absorptive. The face brick on the front of the home should be evaluated by a qualified masonry restoration contractor. At a minimum, the brick will require cleaning and regular applications of clear sealant in order to reduce the risk for ongoing damage to the irreversibly compromised wear layer of the masonry wall.

A. Picture 20 Flaking Brick

A. Picture 21 Flaking Brick Face

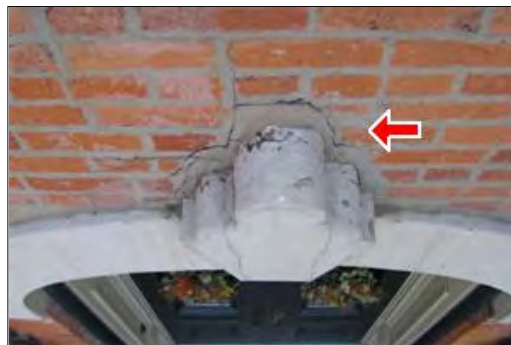
(17) (Picture 24) The mortar around the stone archway at the front of the home is cracked. Repair by a qualified masonry restoration contractor is recommended.

A. Picture 22 Mortar Cracking

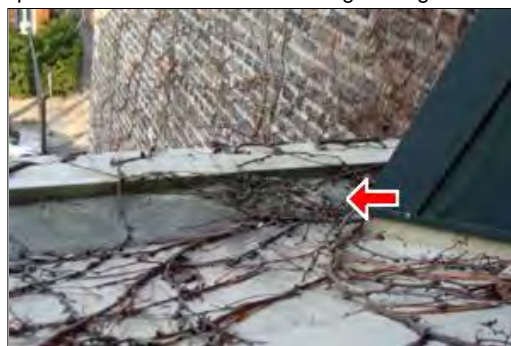
(18) (Picture 25) The vines on the front of the home appear to be blocking the flow of run-off at the mansard roof drain. The vines should be kept trimmed to prevent moisture back-up and to reduce the risk of leaking/damage.

A. Picture 23 Vines on Front of Home

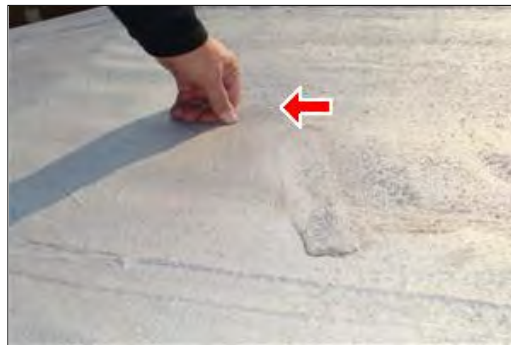
(1) (Picture 1) A number of spongy areas of roof decking were noted. This condition may indicate the presence of rotted and deteriorated roof sheathing. Further review (and perhaps intrusive disassembly of the roof covering) by a qualified roofing contractor is recommended.

C. Picture 1 Spongy Roof Deck

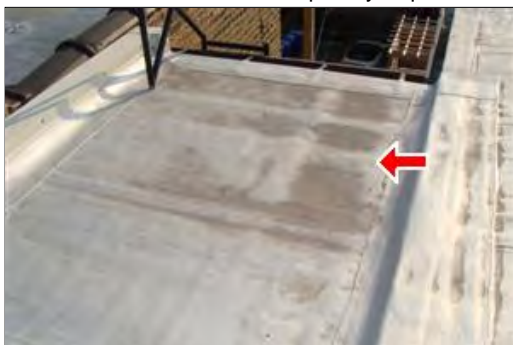
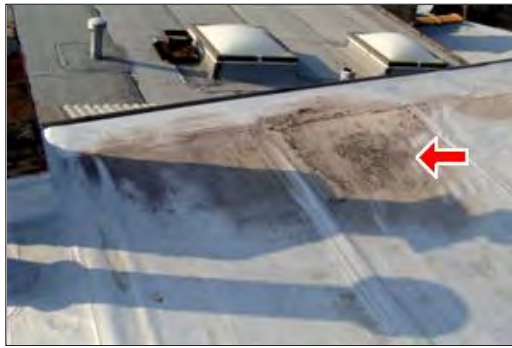
(2) (Picture 2)(Picture 3)(Picture 4) Multiple areas of probable ponding were noted on the roof. Ponding increases the risk of leaking and the rate of roof deterioration. Evaluation and repair by a qualified roofing contractor is recommended.

C. Picture 2 Ponding Evidence

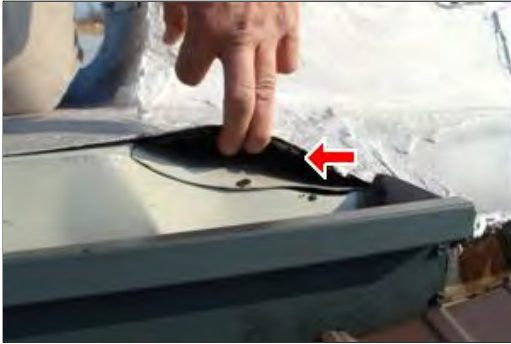
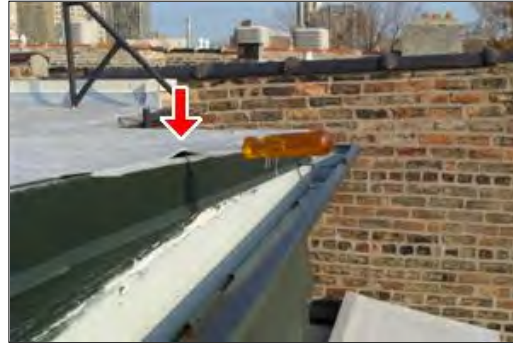
(3) (Picture 5)(Picture 6) Areas of poorly sealed roof covering were noted. Repair by a qualified roofing contractor is recommended in order to reduce the risk for leaking and damage.

C. Picture 5 Unsealed Roof Membrane

C. Picture 6 Gap at Roof Edge

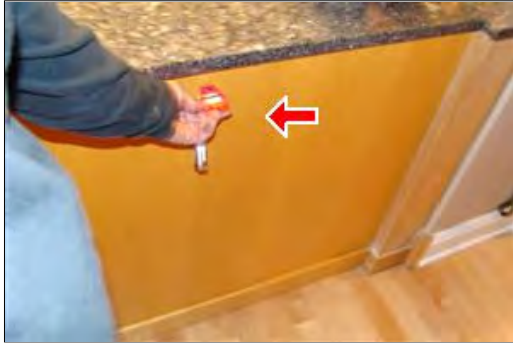
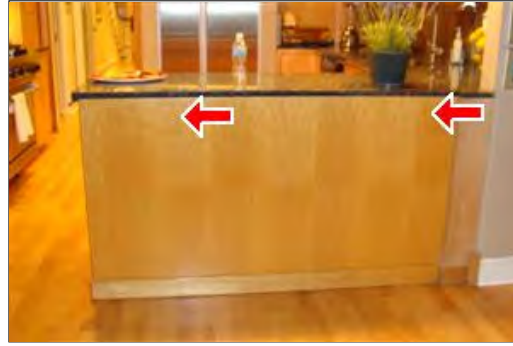
(5) (Picture 5)(Picture 6) The kitchen peninsula should have additional GFCI protected receptacles added for convenience. Standards require a receptacle at every 4 linear feet of kitchen countertop.

E. Picture 5 Missing Receptacle

E. Picture 6 Peninsula

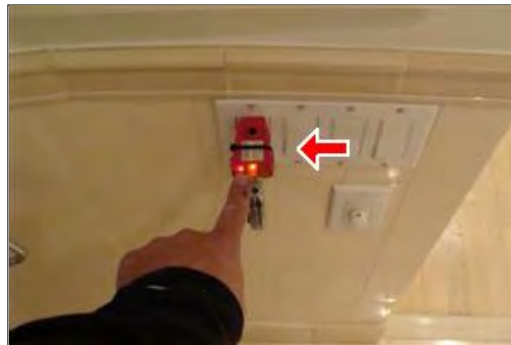
(7) (Picture 8) The electrical receptacle at the north wall of the master bath is not functioning as a safety device. It should be replaced to reduce the risk for shock.

E. Picture 8 Defective GFCI

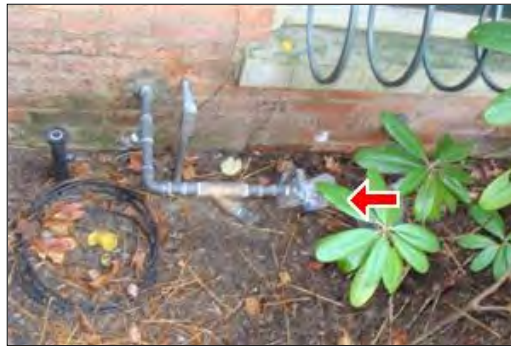
(1) (Picture 1) The underground sprinkler system requires bi-annual maintenance by qualified professionals. All documentation regarding the installation and maintenance of the system should be provided to the buyer as part of the pre-purchase due diligence.

F. Picture 1 Lawn Sprinkler

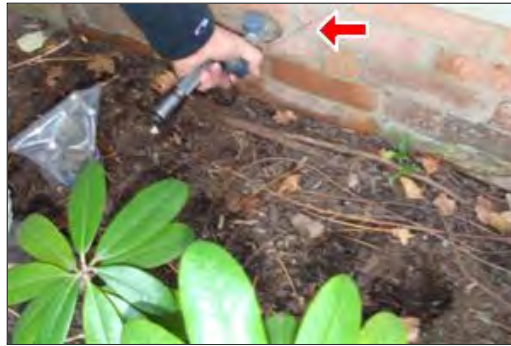
F. Picture 2

(2) (Picture 2) The exterior hose bibbs have been shut-off for the winter. The shut-off valves for each of these fixtures should be identified and labeled prior to closing.

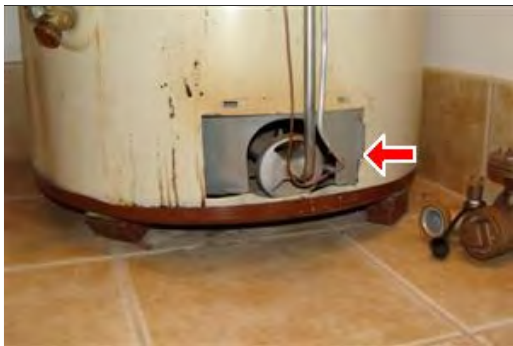
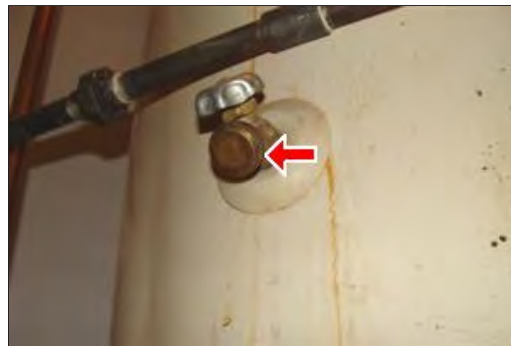
(3) (Picture 3)(Picture 4) The missing combustion chamber cover at the water heater should be furnished and installed in order to reduce the risk of backdrafting and flame roll-out. Also, the drain valve has been capped in an apparent attempt at 'repairing' a leak. The age and inefficiency (relative to newer models) of the water heater may make replacement, rather than repair, the appropriate option.

F. Picture 3 Missing Cover

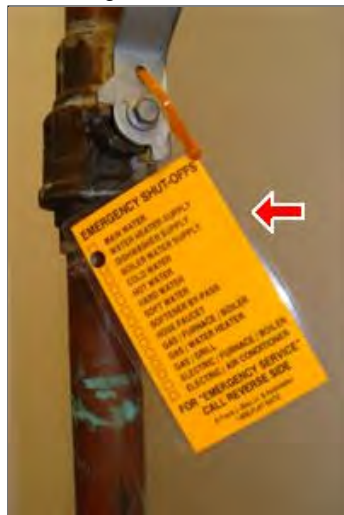
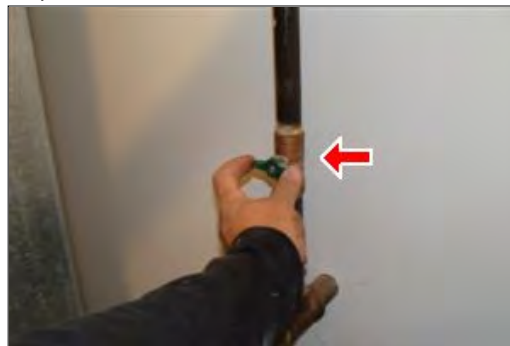
(4) (Picture 5)(Picture 6) All of the plumbing valves in the home should be clearly labeled as to their function and areas which they serve so that they may be used for emergencies, maintenance, and repairs.

F. Picture 5 Valve Label

F. Picture 6 Unlabeled Gas Valve

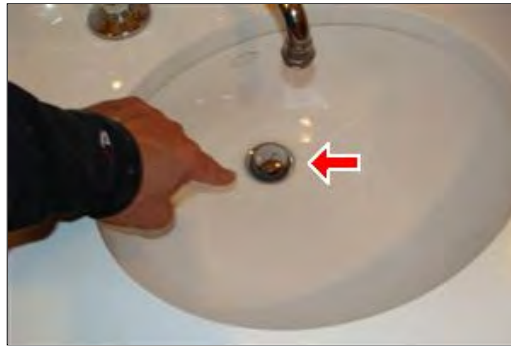
(5) (Picture 7) The lower level bathroom sink drains slowly and should be repaired by a qualified plumber.

F. Picture 7 Slow Drain

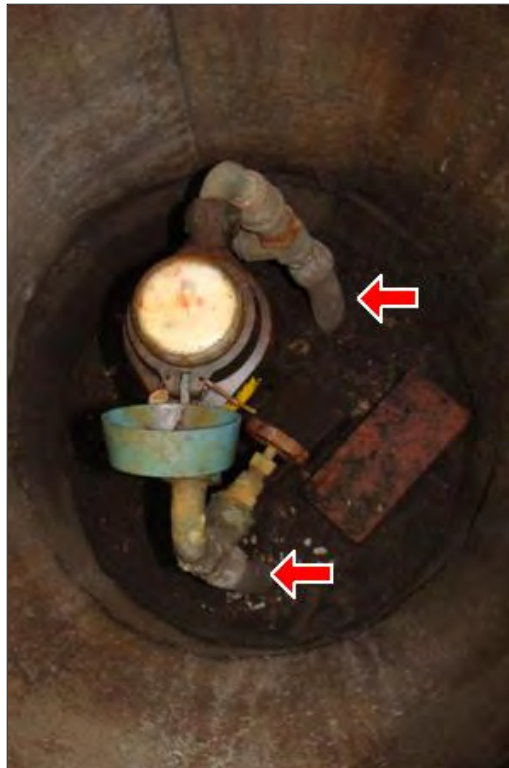
(8) (Picture 10) **Point of Information:** The underground water service piping coming into the home is made, at least partially, of lead. Lead is a neuro-toxic metal that can leach into the water especially during periods of no flow, such as commonly occurs overnight. Many municipalities are considering requiring property owners to replace the existing older lead water services. At a minimum, flushing of the water piping system prior to drinking is recommended after periods of supply piping inactivity. Many water filters are available that are capable of removing most of the lead from the drinking water.

F. Picture 10 Lead Piping in Vault

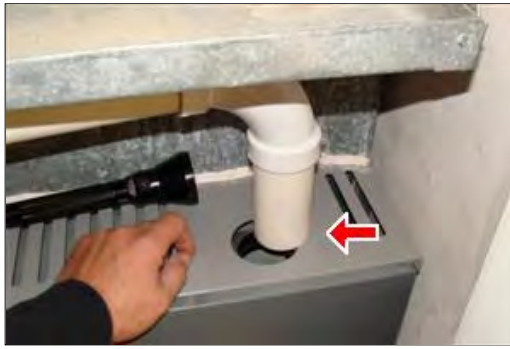
(2) (Picture 2) The PVC intake at the top floor unit should be sealed with RTV compound as required by the manufacturer.

G. Picture 2 Top Floor HVAC Unit

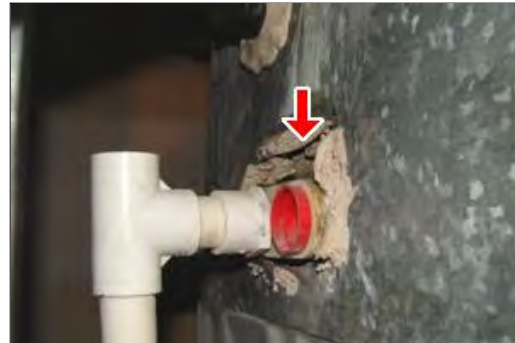
(3) (Picture 3)(Picture 4) Gaps were noted in the supply and return air duct work and/or in the HVAC plenums. These gaps create air leaks which can reduce the efficiency of the HVAC unit, and which can negatively impact both indoor air comfort and indoor air quality. The supply and return air ducts should be sealed using approved materials and methods; duct mastic is the preferred material for duct sealing.

G. Picture 4 Air Gap at Plenum

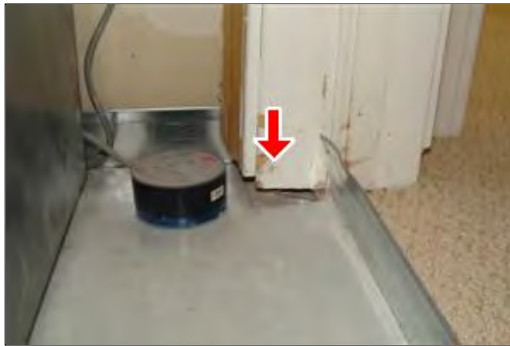
G. Picture 5

(4) (Picture 4) The drain pan underneath the top floor HVAC unit has a large gap at the near right hand corner. If a condensation leak were to occur, the pan would not protect the floor and areas below from damage. The pan should be re-configured by a qualified contractor.

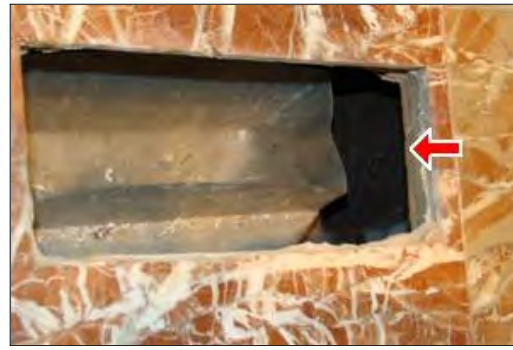
G. Picture 9 Sunken Duct and Boot

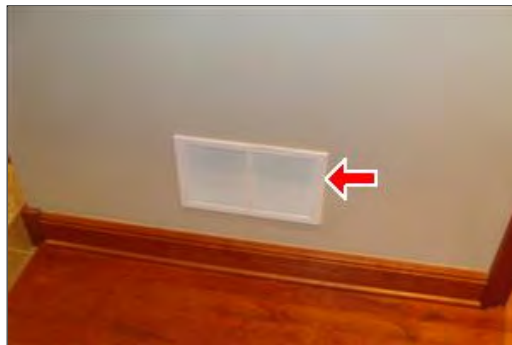
(9) (Picture 13) FYI: At least some of the HVAC air returns are 'panned'. This means that the returns are not made of sheet metal ducts but rather are formed by the wood studs and drywall of the stud channel. This is typically allowed by the minimum standards but makes the ducts leaky and difficult to clean.

G. Picture 13 "Panned" HVAC Air Return

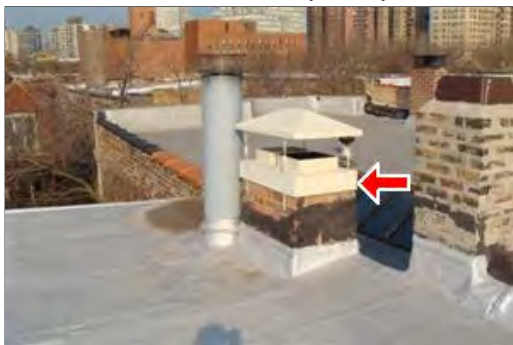
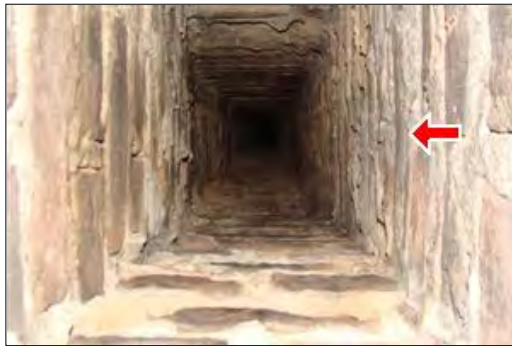
(1) (Picture 1)(Picture 2)(Picture 3) The wood-burning fireplace flues are at least partially unlined. Unlined fireplace flues are unsafe and could pose a risk of fire. The flues should be reviewed and repaired (re-lining appears to be indicated) by a qualified contractor, preferably one who is a member of the Chimney Safety Institute of America (CSIA).

H. Picture 1 Two Flue Chimney

H. Picture 3 North Flue

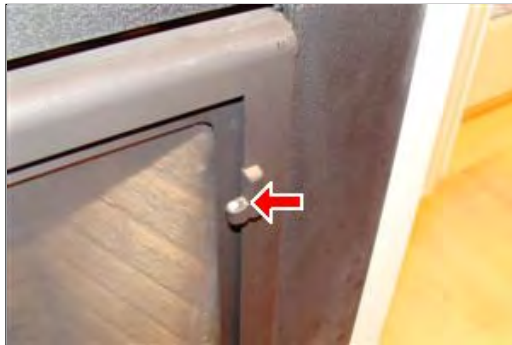
(2) (Picture 4) The dinette area fireplace doors are broken and should be repaired or replaced.

H. Picture 4 Fireplace Door Hinge

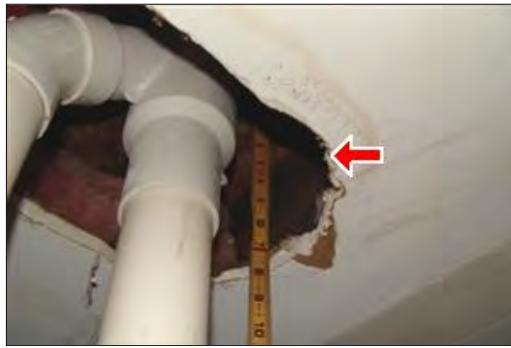
I. Picture 1

(1) (Picture 1) The large hole in the ceiling of the top floor mechanical closet should be sealed in order to reduce the risk for energy losses, condensation in the ceiling/roof plenum, rot and damage.

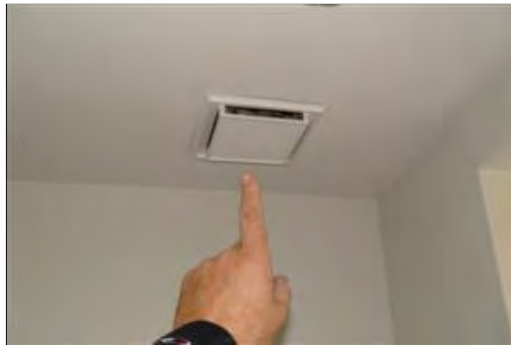
I. Picture 2

(2) (Picture 2) All of the bath fans in the home are loud and cheap. They should be replaced with high quality, quiet exhaust fans.

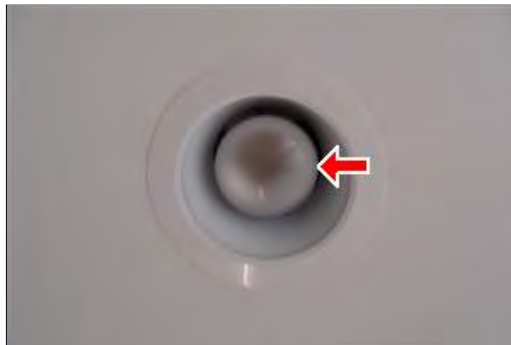
(3) (Picture 3) The can lights at the top floor ceiling may, if they are not air-tight cans, be allowing heat and moisture to flow into the unventilated ceiling/roof plenum. This can result in condensation, rot, mold-growth, etc. The cans should be evaluated by a qualified contractor and should be made air-tight through the installation of gasketed inserts if needed.

I. Picture 3 Can Lighting at Top Floor

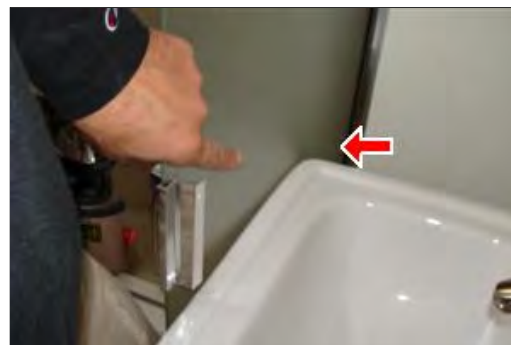
(1) (Picture 1) The glass shower door in the top floor guest bath could strike the nearby pedestal lavatory and break. Door stops, bumpers, or other precautions should be made.

J. Picture 1 Breakage Hazard

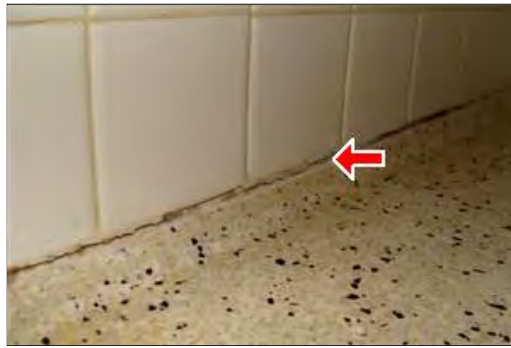
(2) (Picture 2) The caulking at the base of the top floor guest bath shower stall should be removed and replaced.

J. Picture 2 Degraded Caulk

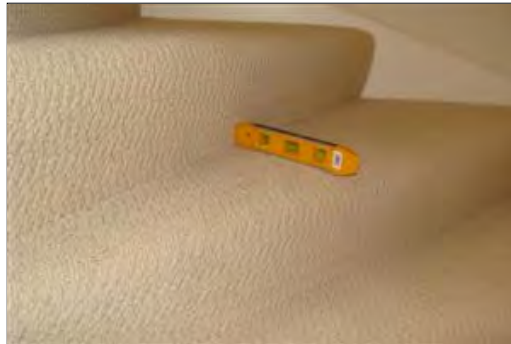
(3) (Picture 3) The carpeted, winding stairs leading to the top floor are dangerous. The treads in the winding stair section are excessively sloped and narrow. The stairs should be evaluated for repair by a qualified carpenter.

J. Picture 3 Excess Tread Slope

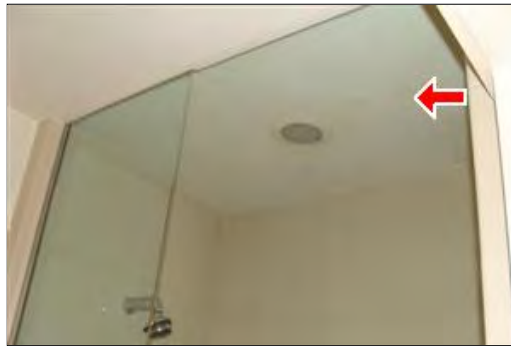
(6) (Picture 6) It is recommended that the master bath shower ceiling be protected from moisture damage by the installation of matching tile.

J. Picture 6 At Risk Ceiling

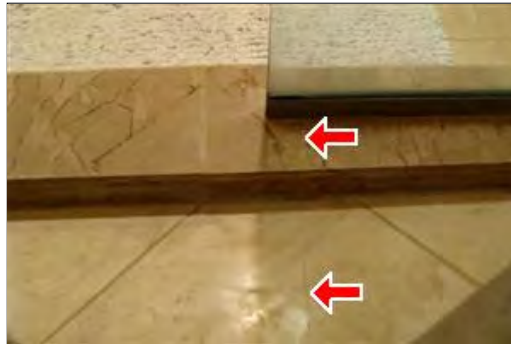
(7) (Picture 7) The master bath shower base is cracked and high moisture levels were noted at the tile substrate in the cracked area. The tile shower base should be repaired by a qualified tile setting contractor.

J. Picture 7 Tile Cracking and High Moisture

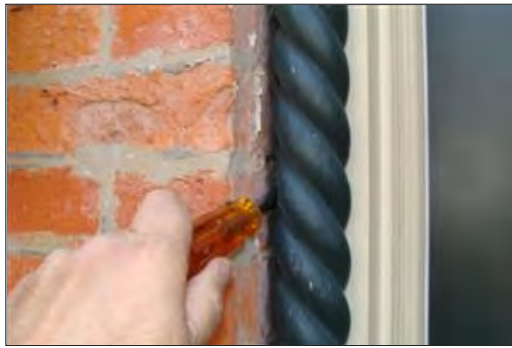
(2) (Picture 2) The spiral trim at the front door is open to weather and pests; it should be sealed with the appropriate caulking material and methods.

K. Picture 2 Unsealed Trim

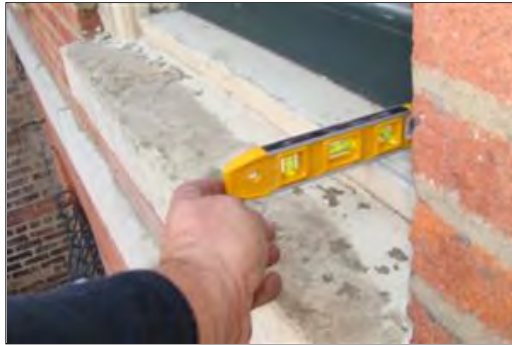
K. Picture 3

(3) (Picture 3) The exterior windowsills at the front of the home are not sloped to shed moisture and the interiors of the windows do not have a raised apron. These conditions make moisture intrusion and rot a virtual certainty. Evidence of such intrusion and rot were noted in multiple locations. The windows assemblies should be evaluated and repaired by a qualified carpenter.

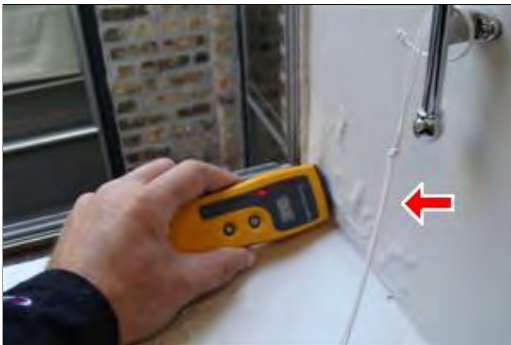
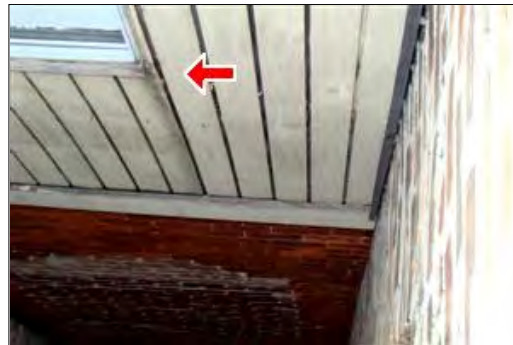
(4) (Picture 4)(Picture 5) Moisture damage and elevated moisture levels were noted at the right hand jamb of the top floor guest bath window. The single-glazed aluminum window should be replaced with a high quality energy efficient window. The deteriorated and displaced plywood siding on the the wall outside of this bathroom should also be replaced.

K. Picture 5 Plywood Siding at East Elevation Light Well

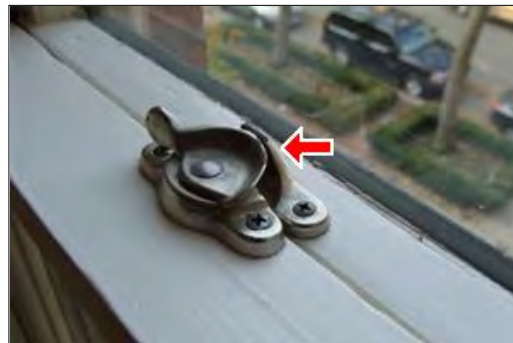
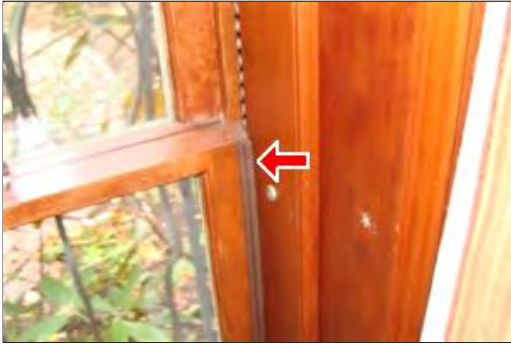
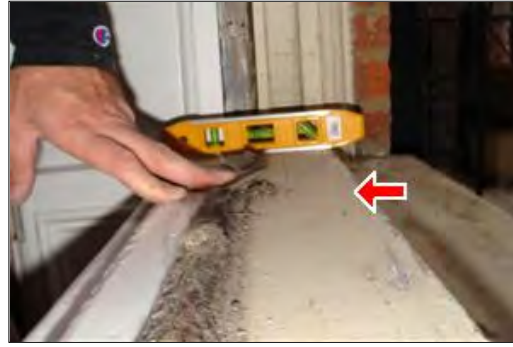
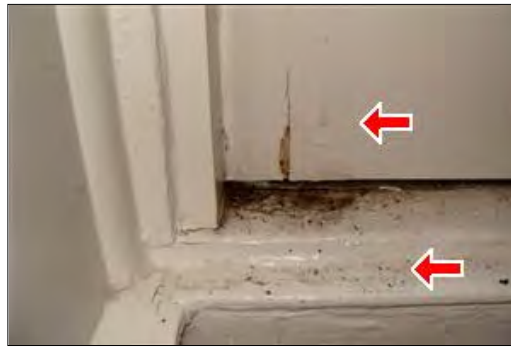
(6) (Picture 6)(Picture 7)(Picture 8)(Picture 9)(Picture 10) Multiple problems were noted with the windows in the home. Ongoing moisture damage due to improperly pitched sills, inadequate weatherstripping, and broken window hardware were all noted. The windows should be individually evaluated and repaired as needed for weather resistance and energy efficiency.

K. Picture 7 Broken Window Latch

K. Picture 8 Loose Weatherstripping

K. Picture 9 Back-pitched Sill

K. Picture 10 Painted-over Damage at 1st Floor North Wall Window

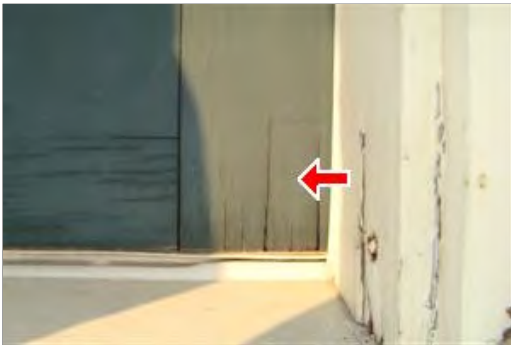
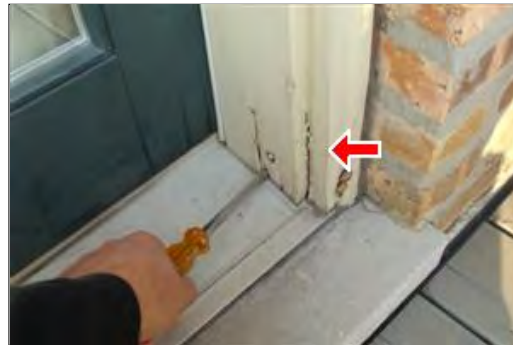
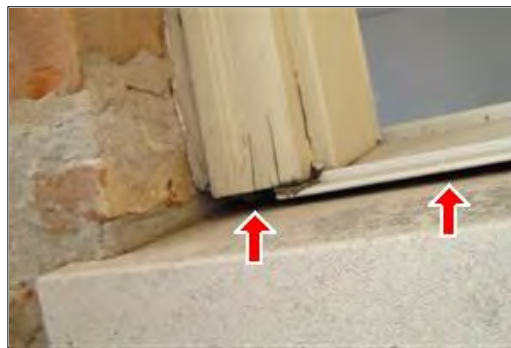
(7) (Picture 8)(Picture 9)(Picture 10) The 3 doors to the large balcony at the living room south wall exhibited varying amounts of moisture damage and wear. The doors and frames should be repaired or replaced as needed to reduce the risk for further damage.

K. Picture 11 Weather Damage at Door

K. Picture 12 Rot at Door Jamb

K. Picture 13 Missing Sealant at Balcony Door

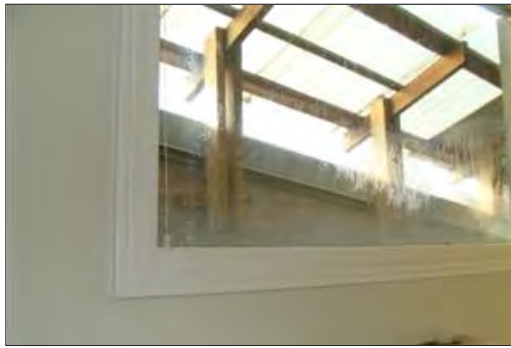
(8) (Picture 14) The large fixed pane window at the west hallway wall has a blown thermal seal and should be replaced.

K. Picture 14 Blown Thermal Seal

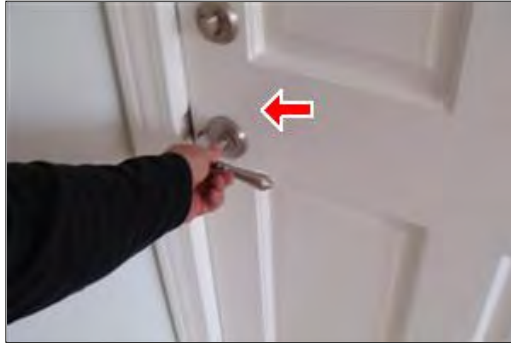
(9) (Picture 15) The door from the rear top floor bedroom to the east hallway is missing its weatherstripping (this is a pre-hung exterior door) and is therefore hinge-bound. The missing weatherstripping should be installed.

K. Picture 15 Hinge-bound door

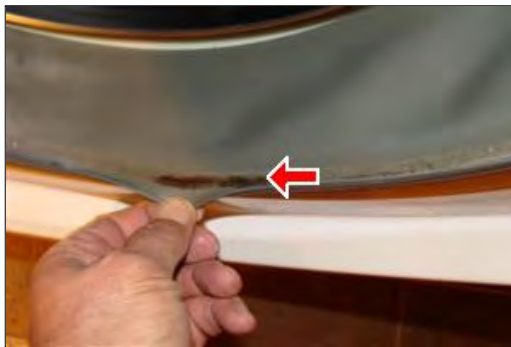
(1) (Picture 1) Mold-like growth was noted at the rubber seal of the front loading clothes washer in the lower level. The washer should be cleaned regularly to prevent mold growth. Products are available that can be introduced into the washer during a wash cycle and which will address this condition. Consumers can often find websites devoted to a particular make and model of clothes washer which will provide further information.

L. Picture 1 Mold-like Growth

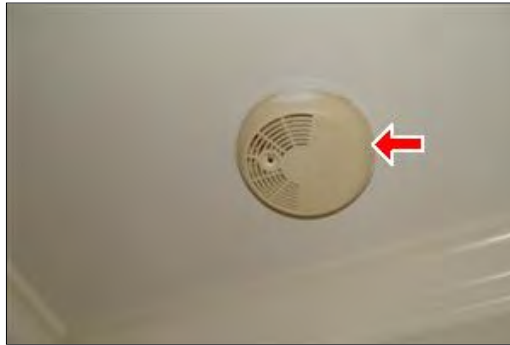
(Picture 1) The smoke detectors noted in the home appeared to be at or beyond the end of their service lives, typically taken to be 10 years for smoke detectors and 5 years for carbon monoxide detectors. It is recommended that the smoke detector and carbon monoxide detector systems be upgraded to reflect current life safety codes which include; smoke detectors on each level of living space and in each sleeping room, hard-wired 120 V smoke detectors that are interconnected in order to alarm simultaneously when any individual smoke detector responds, and carbon monoxide detectors and every level of living space and within 15 feet of a sleeping room. The installation of these critical life safety devices by a licensed and competent electrician is recommended.

M. Picture 1 Aged Detector
