## Inspection Report

Chicago IL

## Domicile Consulting

<b>Date:</b> 11/14/2009	<b>Time:</b> 01:00 PM	<b>Report ID:</b> 11/14/09/01
<b>Property:</b> Chicago IL	<b>Customer:</b>	<b>Real Estate Professional:</b>

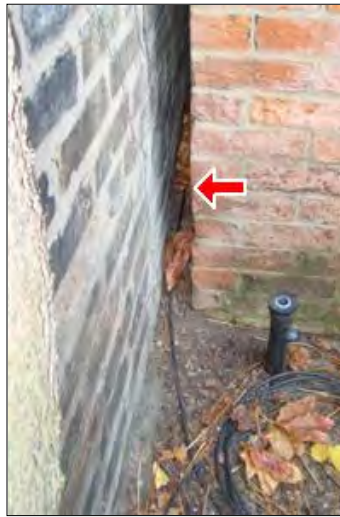
A. Picture 1

(1) (Picture 1) The space between the subject building and it's neighbor to the east should be protected from entry by rats, cats, and other animals by the installation of a porous material such as hardware mesh.

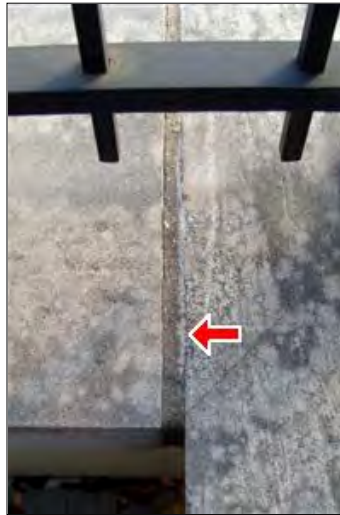
A. Picture 16

(13) (Picture 16) The butt joints between the limestone coping blocks should be raked down and sealed with urethane caulk in order to reduce the risk for moisture penetration and masonry damage.

13. (13) (Picture 16) The butt joints between the limestone coping blocks should be raked down and sealed with urethane caulk in order to reduce the risk for moisture penetration and masonry damage.

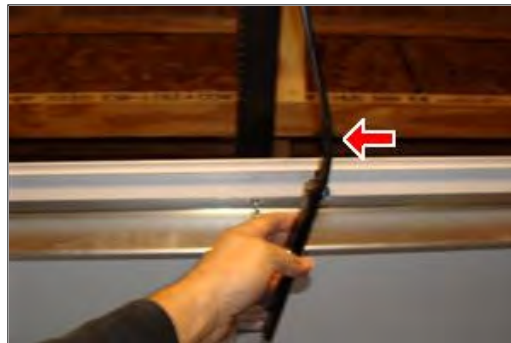
B. Picture 1

(Picture 1) The connecting arm of the automatic garage door opener is bent. It should be replaced.

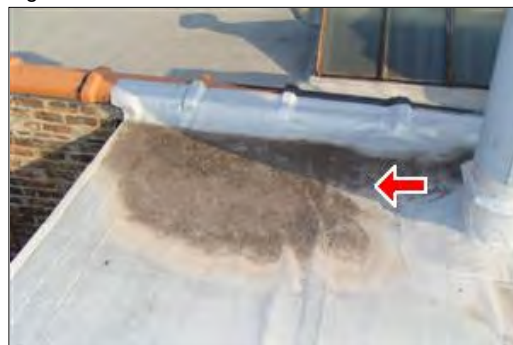
(2) (Picture 2)(Picture 3)(Picture 4) Multiple areas of probable ponding were noted on the roof. Ponding increases the risk of leaking and the rate of roof deterioration. Evaluation and repair by a qualified roofing contractor is recommended.

C. Picture 3 Ponding Evidence

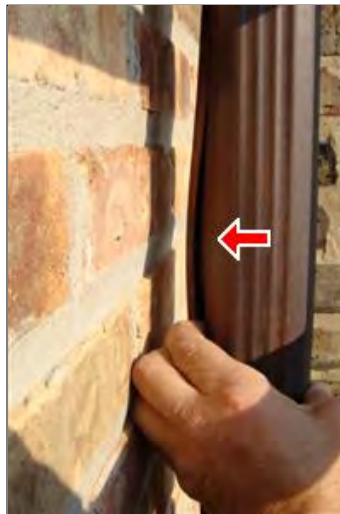
(4) (Picture 7) The downspout outside the top floor rear entry door is split and should be replaced. It may be advisable to install gutter guards to reduce the risk for gutter and downspout clogging.

C. Picture 7 Split Downspout

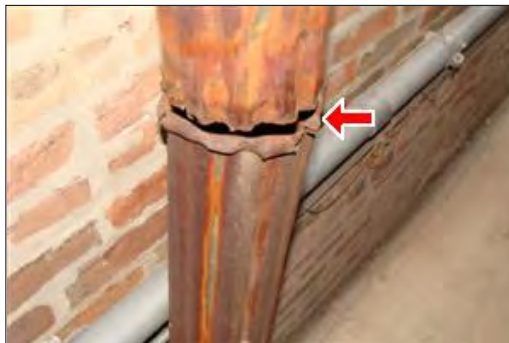
(5) (Picture 8) The open downspout joint on the west exterior elevation should be repaired to prevent moisture damage to the adjacent masonry.

C. Picture 8 Open Downspout Joint

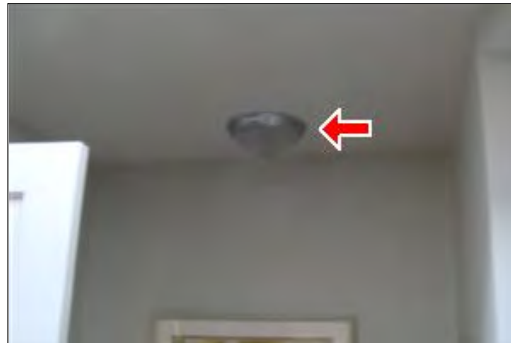
(1) (Picture 1) The light fixture above the top floor guest bath tub should be repaired or replaced.

E. Picture 1 Non-Functioning Light Fixture

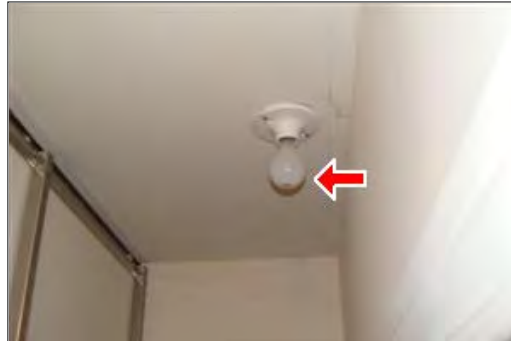
(2) (Picture 2) The bare bulb light fixtures in the closets should be replaced with low-profile fluorescent fixtures in order to reduce the fire hazard associated with their hot surfaces and also in order to reduce the risk of bulb breakage.

E. Picture 2 Closet Light Fixture

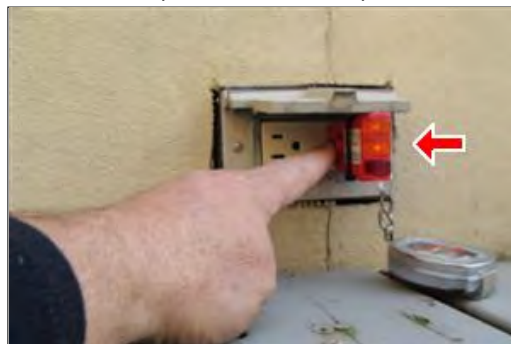
(3) (Picture 3) All exterior electrical receptacles should be provided with GFCI protection in order to reduce the risk of electrical shock.

E. Picture 3 Non-GFCI Receptacle at Balcony

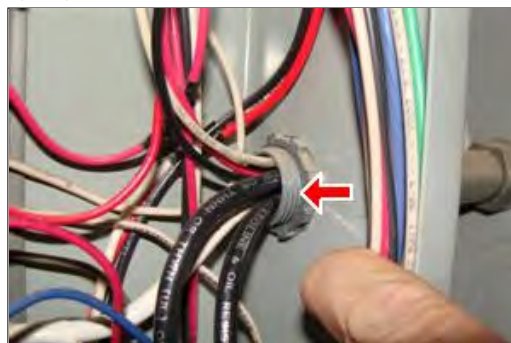
(4) (Picture 4) The high ampacity conductors at the service panel feed-through should be protected by plastic anti-chafing devices in order to reduce the risk for arcing/sparking, shock, fire, etc.

E. Picture 4 Inadequately Protected Conductors

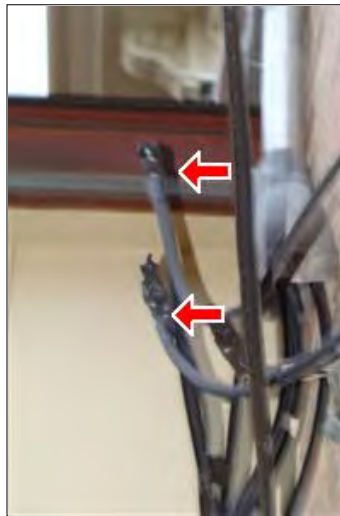
E. Picture 7

(6) (Picture 7) The taped-over splices at the electrical service wiring on the west wall of the home should be secured and sealed with approved devices.

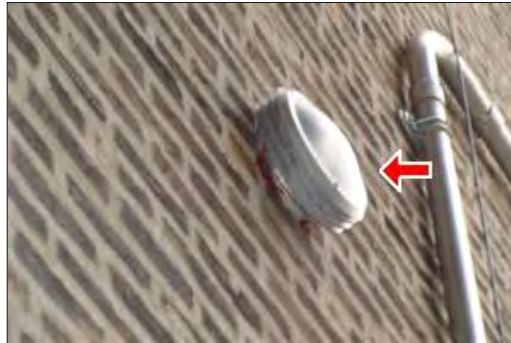
(6) (Picture 8) The kitchen range hood vent cap is not made for this use. The existing vent cap is intended for use on gas-fired equipment and does not have an integral backdraft damper. The existing vent cap should be replaced for proper ventilation and improved energy efficiency.

F. Picture 8 Kitchen Range Hood Vent Termination

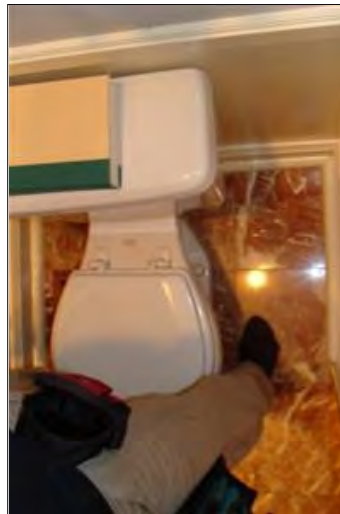
F. Picture 9

(7) (Picture 9) The main floor powder room is loose and may be leaking at it's drain connection. The toilet should be removed, repaired, and reinstalled by a qualified plumber.

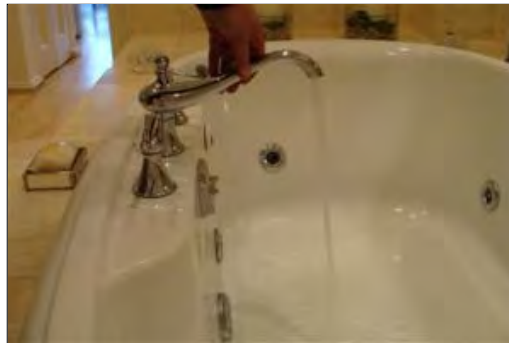
(9) (Picture 10) The master bath tub spout should be secured to prevent leaking and damage.

F. Picture 11 Loose Spout

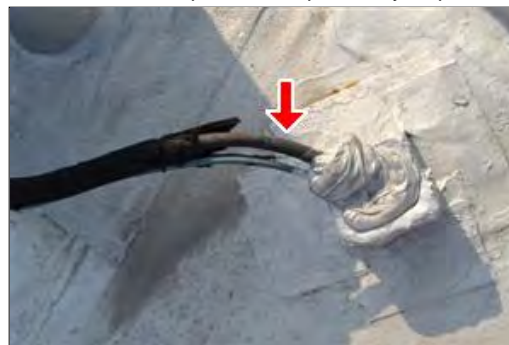
(1) (Picture 1) The A/C refrigerant line insulation should be repaired or replaced by a qualified HVAC contractor for energy efficiency.

G. Picture 1 Missing Insulation

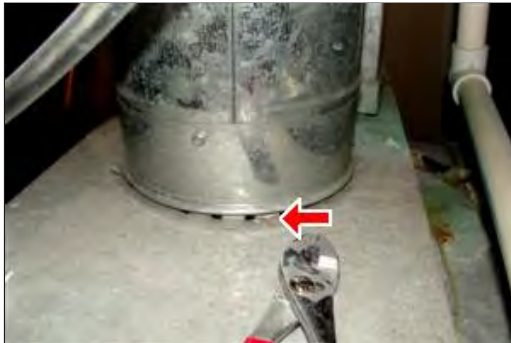
(3) (Picture 3)(Picture 4) Gaps were noted in the supply and return air duct work and/or in the HVAC plenums. These gaps create air leaks which can reduce the efficiency of the HVAC unit, and which can negatively impact both indoor air comfort and indoor air quality. The supply and return air ducts should be sealed using approved materials and methods; duct mastic is the preferred material for duct sealing.

G. Picture 3 HVAC Duct Gaps

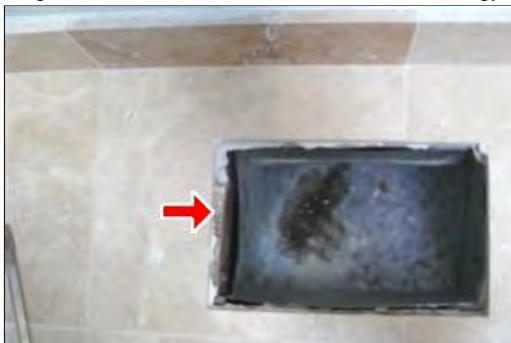
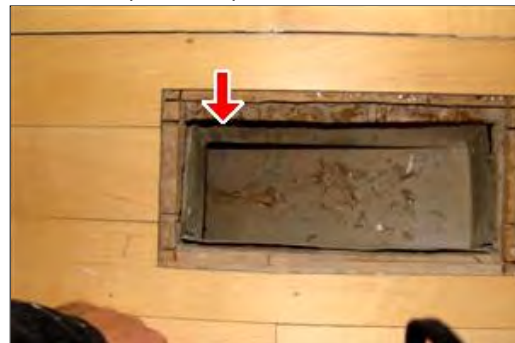
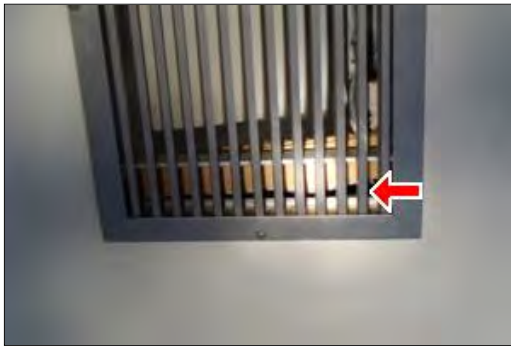
(5) (Picture 6)(Picture 7)(Picture 8)(Picture 9) Most of the registers in the home are poorly sealed and secured at the floor openings. The gaps at the register boots should be sealed to reduce energy losses and to promote optimal HVAC airflow.

G. Picture 6 Gap at Register Boot

G. Picture 7 Gap at Register Boot

G. Picture 8 Large Gap at Return Register

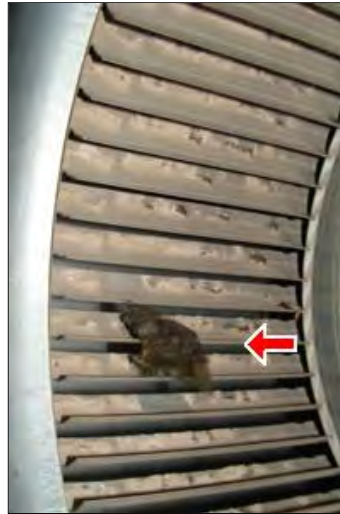
G. Picture 10

(6) (Picture 10) Heavy dirt build-up was noted on the interior components of the lower level HVAC system. This can reduce the efficiency of the system and can also reduce indoor air comfort. The entire HVAC unit; including the blower assembly, heat exchanger, and evaporator coil should be professionally cleaned for optimal system performance.

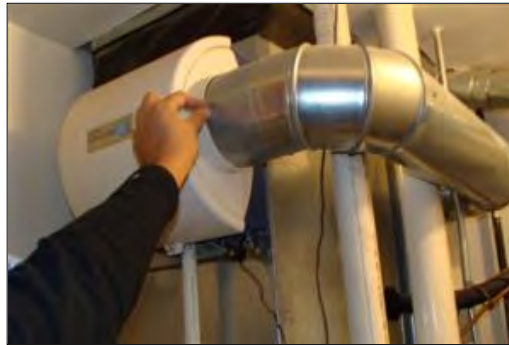
(7) (Picture 11) The missing damper at the lower level furnace-mounted humidifier should be installed for improved energy efficiency during the cooling mode.

G. Picture 11 Missing Damper

51. (7) (Picture 11) The missing damper at the lower level furnace-mounted humidifier should be installed for improved energy efficiency during the cooling mode.

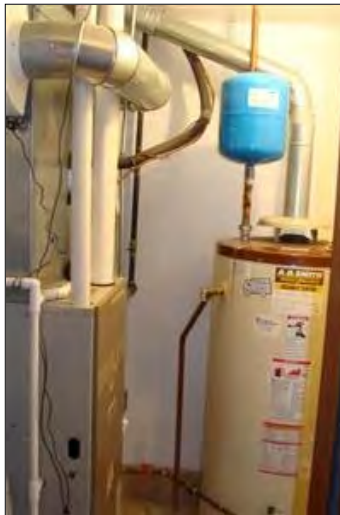
(8) (Picture 12) The mechanical room has insufficient access to combustion/dilution air for the gas-fired appliance (water heater) that is located inside. Evaluation and repair by a licensed and competent mechanical contractor is recommended in order to reduce the risk of equipment damage, inefficient combustion, and infiltration of carbon monoxide to the living space.

G. Picture 12 Natural Draft Water Heater

52. (8) (Picture 12) The mechanical room has insufficient access to combustion/dilution air for the gas-fired appliance (water heater) that is located inside. Evaluation and repair by a licensed and competent mechanical contractor is recommended in order to reduce the risk of equipment damage, inefficient combustion, and infiltration of carbon monoxide to the living space.

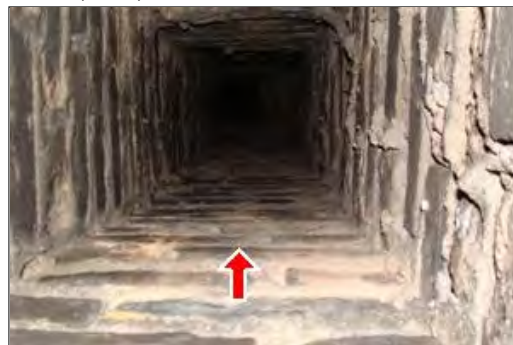
H. Picture 2 South Flue

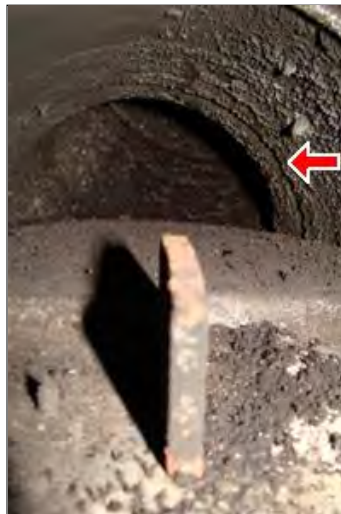
(3) (Picture 5) Significant soot build-up was noted inside the wood-burning fireplace flue. The National Fire Protection Agency recommends that fireplaces be thoroughly evaluated when a home changes ownership. Evaluation and cleaning of the fireplaces in the home by a qualified specialty contractor, preferably one who is a member of the Chimney Safety Institute of America, is recommended.

H. Picture 5 Accretions Inside Living Room Fireplace Flue

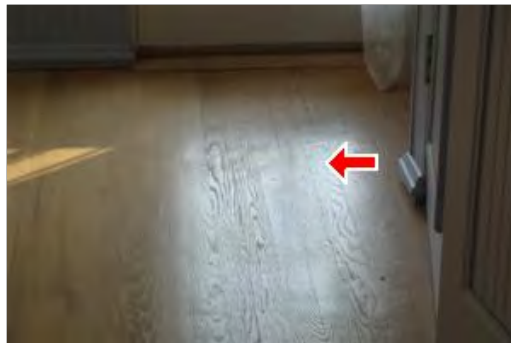
J. Picture 4

(4) (Picture 4) Areas of hardwood flooring finish deterioration were noted. The floors should be refinished as needed by a qualified contractor.

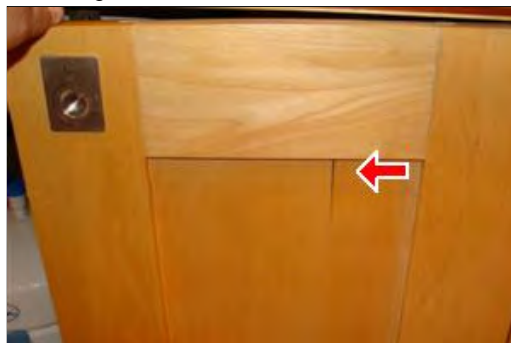
J. Picture 5

(5) (Picture 5) Moisture damage was noted at the right hand kitchen sink base cabinet door. The door should be repaired or replaced.

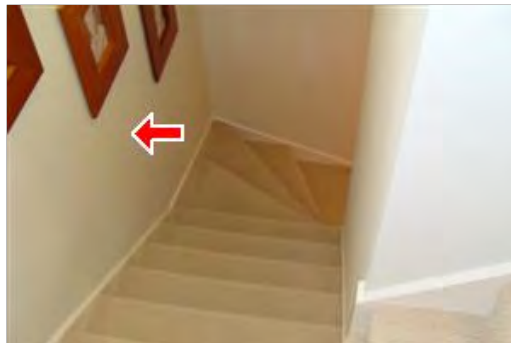
(8) (Picture 8) Secure and graspable handrails should be installed at all of the interior stairs in order to provide for safe stair travel.

J. Picture 8 Missing Railing

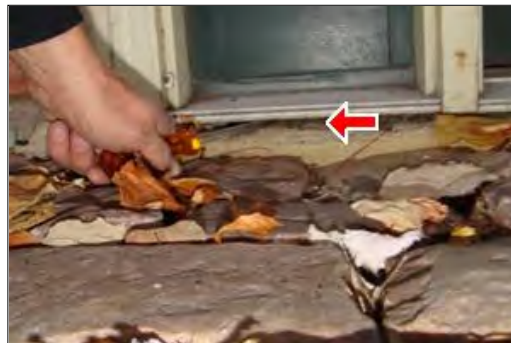
K. Picture 1

(1) (Picture 1) The lower level front entry doorsill is open to weather and pests. It should be secured and sealed.

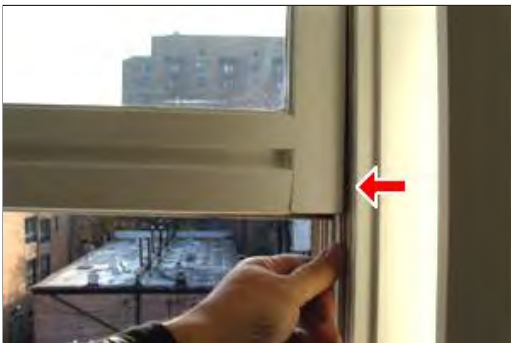
K. Picture 6

(6) (Picture 6)(Picture 7)(Picture 8)(Picture 9)(Picture 10) Multiple problems were noted with the windows in the home. Ongoing moisture damage due to improperly pitched sills, inadequate weatherstripping, and broken window hardware were all noted. The windows should be individually evaluated and repaired as needed for weather resistance and energy efficiency.

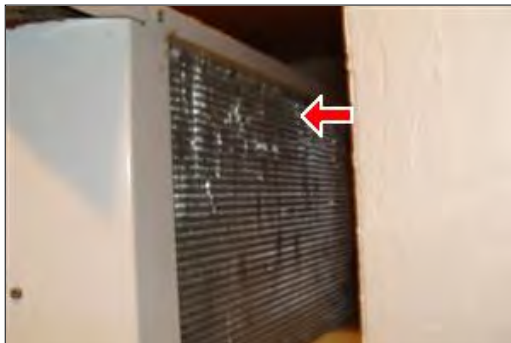
L. Picture 2

(2) (Picture 2) The refrigerator compressor and other interior operating components should be thoroughly and professionally cleaned for operating efficiency and equipment longevity.

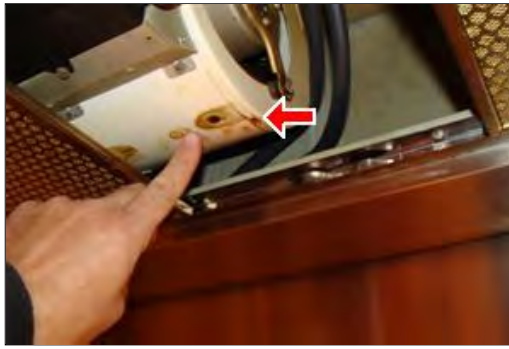
(3) (Picture 3) The kitchen exhaust fan is greasy and should be cleaned.

L. Picture 3 Grease at Exhaust Fan
